Lightning Cable Replacement Instructions:  
PowerSync Cart® 40 for iPad and iPad mini  
(HE405 & HE407)

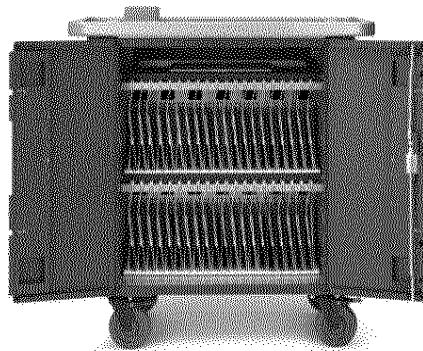
1. Turn off and unplug the PowerSync Cart® 20 or 40.

Open the front doors of the cart.

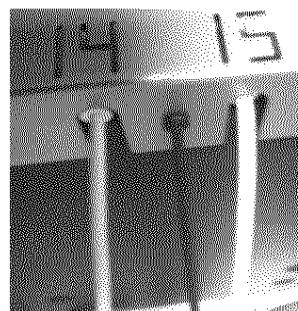
2. To gain access to the 20 right angle Lightning cables, the cable management bracket will need to be removed.

It is held in place by four M3 security screws or four Phillips headed screws.

A 2mm hex key or 5/64 Allen wrench will be used to remove the security screws or a Philips headed screw driver will work.

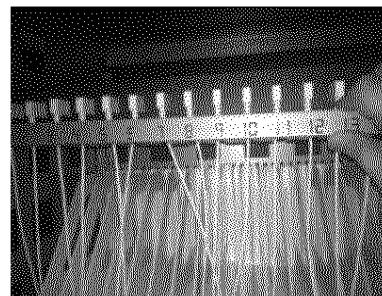
3. With the four security screws removed, the cable management bracket can be lifted out of place.

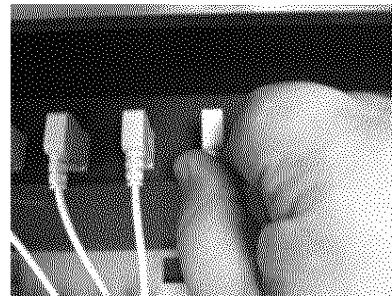
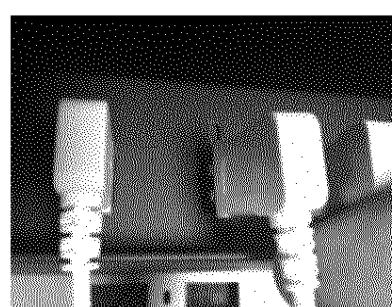
4. Now the defective right angle Lightning cable can be removed.

The new Lightning cable can be inserted into the USB port in the cart's power module.

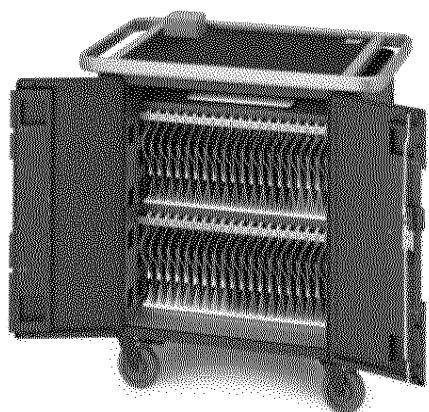
6. Repeat step 4 for the remaining right angle Lightning cables that need to be replaced.

Once complete, the cable management bracket can be put back into place and reattached.

Finally, plug the cart back into a wall outlet and turn the power switch on for use.
